FIELD SURVEYS, IOC VALLEYS. VOLUME I. PROGRAM OVERVIEW AND METH--ETC(U)

UNCLASSIFIED E-TR-48-VOL-1

MX SITING INVESTIGATION
DEPARTMENT OF THE AIR FORCE
BMO/AFRCE-MX

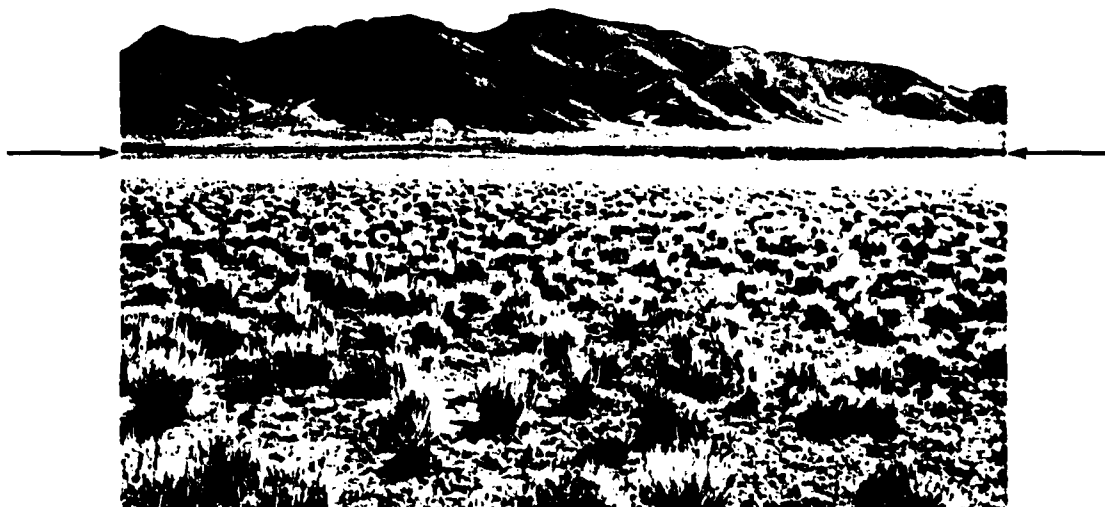
Shelter 2-22 was located in close proximity to a prominent fault scarp that was difficult to recognize as a fault on the detailed topographic maps (Figure 3-3). The shelter was relocated approximately 1000 feet (310 m) from the scarp on the upthrown block. The road to the shelter will cross the scarp and fault zone. The fault near Shelter 7-2 was identified from aerial photographic interpretation and verified by a magnetometer survey. There was little to no topographic expression of the fault. Shelters 4-1 and 4-22 are on trend with large ground cracks or fissures. The fissures vary from 2 to 15 feet (0.6 to 5 m) deep and 1 to 8 feet (0.3 to 2 m) wide (Figure 3-4). There is no evidence of offset along these features. The cracks or fissures propagate in a generally straight or slightly arcuate manner. Although the cracks are thought to present a construction nuisance rather than impacting the structural integrity of

AERIAL VIEW OF FAULT SCARP ON EAST SIDE OF DRY LAKE VALLEY.

GROUND VIEW OF FAULT SCARP ON EAST SIDE OF DRY LAKE VALLEY.

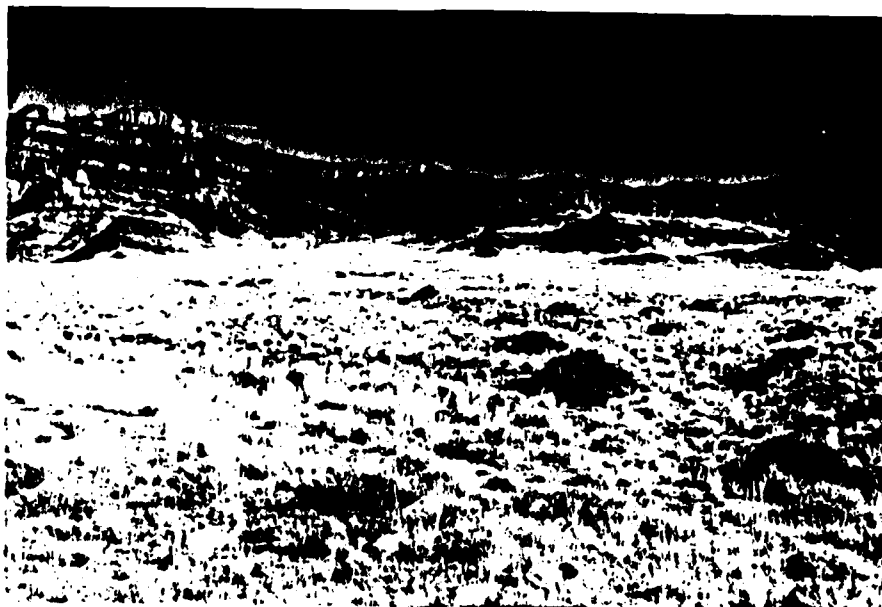
GENERALIZED SITE ON THE EAST SIDE OF PINE VALLEY (HSS 3-7). FANS ON THIS SIDE OF THE VALLEY WERE TYPIFIED BY DEEP, ACTIVE DRAINAGES WITH COBBLES.

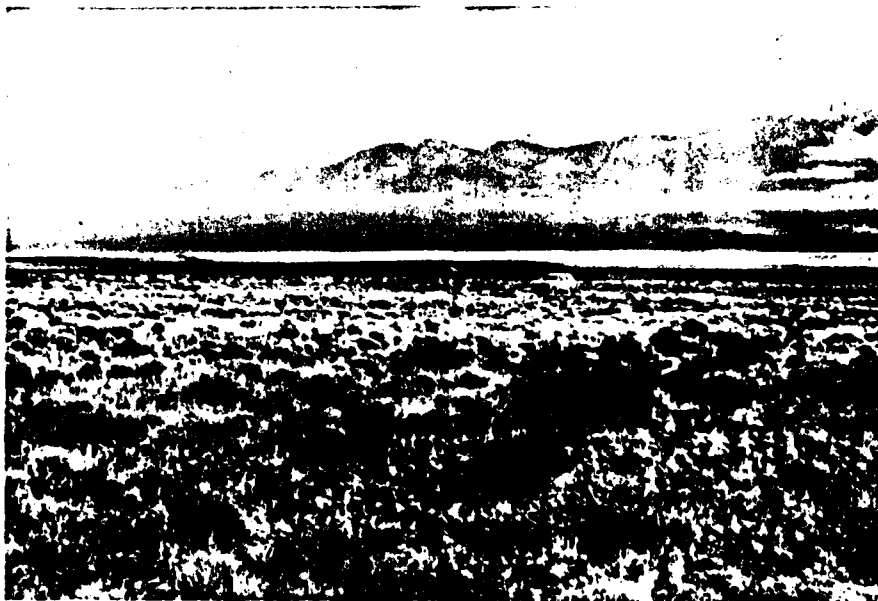
Ertec Western, Inc. recommended relocation of HSS 3-3, located on a small, steep, active fan on the west side of the valley (Figure 5-3). The fan surface was characterized by numerous distributary channels, 3- to 4-foot (0.9- to 1.2-m) boulders on the surface, and smaller cobbles in the channel bottoms. Relocation of this site to the closest suitable site would have required an additional 1 mile (1.6 km) of cluster road, which was considered more costly than remedial construction measures; the relocation was not approved by BMO/AFRCE. All sites moved for geotechnical reasons could have been constructed as originally staked, but relocations will reduce the number of drainage structures and grading required for drainage control.

ACTIVE FANS ON THE WEST SIDE OF WAH WAH VALLEY (HSS 3-3, VIEW E TOWARD TPB).
FAN SURFACE WAS CHARACTERIZED BY LARGE BOULDERS (2 FT. - 3 FT. IN DIAMETER).

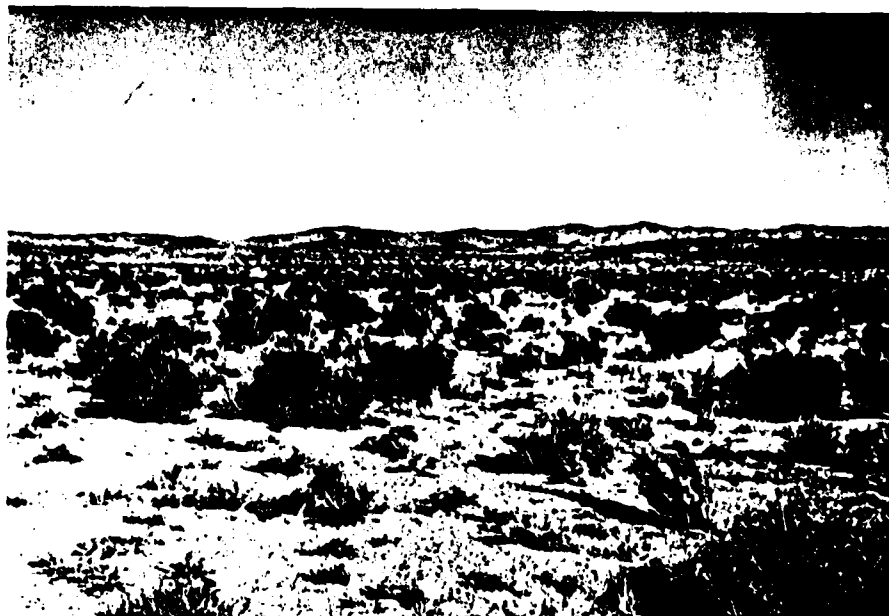
GENERALIZED OVERVIEW OF A TYPICAL SITE (WAH WAH HSS 4-15). NOTE FLAT TERRAIN, LACK OF WASHES, AND LOOSE SANDY SOIL. VIEW NE OF SITE FROM THE TPB.

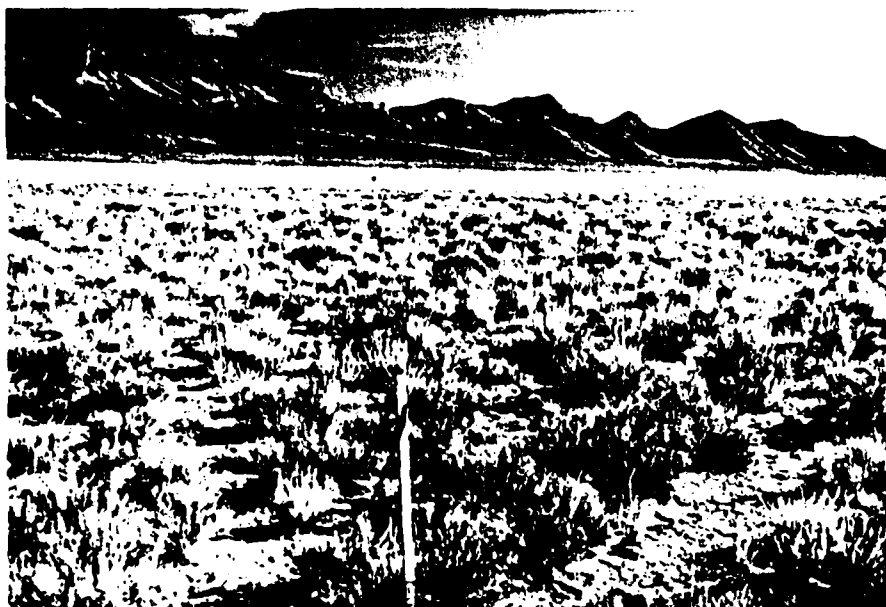
Washes cutting through the site posed the major construction consideration and dictated the largest number of shelter and CMF relocations. Processes in alluvial valleys are dynamic; one can always expect portions of the valley to be active. Washes within the valley, especially those on the flanks of the valley, are active, evidenced by vegetation within the channel (indication of the presence of water), active erosion and undercutting of the banks, size and distribution of bedload materials, and size of drainage area. An estimate of the degree of activity, as well as the extent of the drainage area, was required prior to recommending a site for relocation. Figure A2-4 is an example of a wash cutting through a site near the center monument. This

SMALL DRAINAGE COURSES ARE APPARENT ON THE SURFACE OF THE HSS, AS INDICATED BY LACK OF VEGETATION, DEPRESSIONS, AND CRACKS IN THE SURFACE MATERIAL. VIEW TO THE SE FROM THE REAR MONUMENT (DRY LAKE VALLEY HSS 8-13).

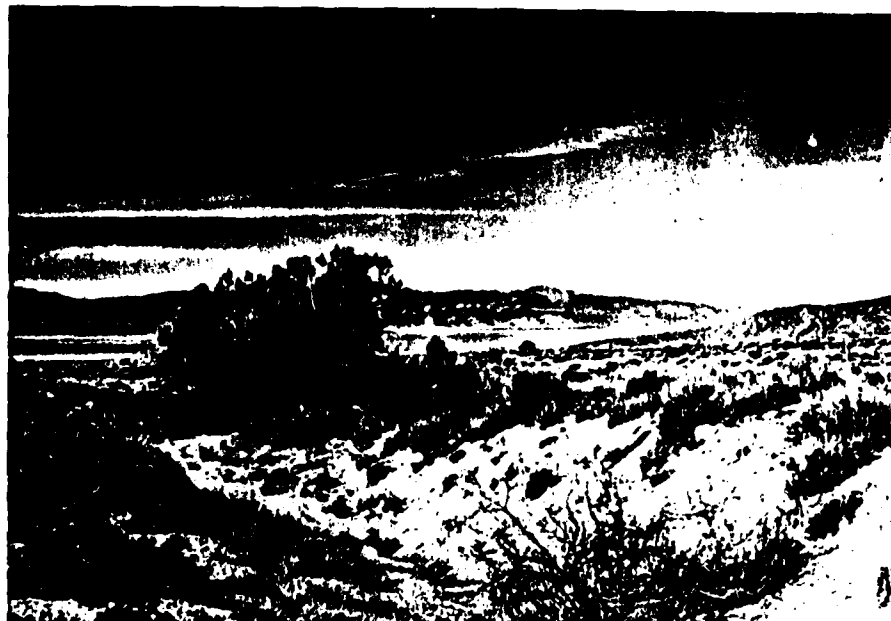
MAJOR WASH CUTTING THROUGH SITE BETWEEN THE CENTER AND REAR MONUMENTS
(NOTE REAR MONUMENT AT THE RIGHT OF THE PHOTO) (DRY LAKE VALLEY HSS 5-22).
